# Inspection Report

**Property Address:**  
 111 Your New Address  
 Newtown NH/VT

**Threshold Home Inspection, LLC**

<b>Date:</b> 9/28/2010	<b>Time:</b> 09:00 AM	<b>Report ID:</b> 0038
<b>Property:</b> 111 Your New Address Newtown NH/VT	<b>Customer:</b> Your Name

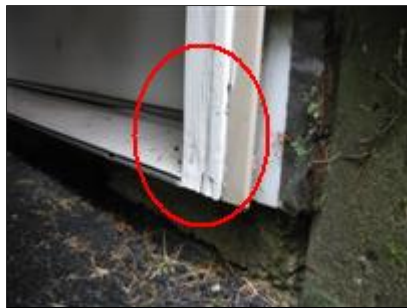
2.1 Picture 1

**2.1** (1) MM The casings and and jambs in three locations exhibit moisture damage/rot that needs attention before the damage threatens the integrity of the door /jamb unit. Minwax wood hardener and Minwax wood filler are suggested for repairs. The three locations are:

- The side door to the garage.(Picture 1)
- The left side of the rear door to the garage.(Picture 2)
- The right side of the rear door to the garage. (Picture 3)

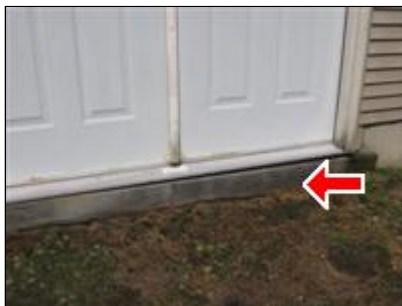
2.1 Picture 4

(2) MM The board beneath the rear garage door that supports the metal threshold is no longer functioning. (Picture 4) I recommend replacement.

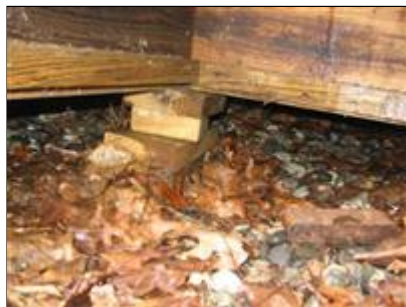
2.3 Picture 1

**2.3 RR** The supports beneath the lower deck are not adequate or typical. The supports near the house are stacks of scrap lumber (Picture 1), and the carrying beam near the front is laid on the edge of the concrete piers, and dose not appear to be secured (Picture 2). Some sag has occurred near the removable decking adjacent to the basement vent window. Failure will not result in a dangerous deck collapse because the deck is so close to grade. I would still recommend further evaluation to determine if more adequate supports are needed in order to maintain the integrity of the deck structure.

1. RR The supports beneath the lower deck are not adequate or typical. The supports near the house are stacks of scrap lumber (Picture 1), and the carrying beam near the front is laid on the edge of the concrete piers, and dose not appear to be secured (Picture 2). Some sag has occurred near the removable decking adjacent to the basement vent window. Failure will not result in a dangerous deck collapse because the deck is so close to grade. I would still recommend further evaluation to determine if more adequate supports are needed in order to maintain the integrity of the deck structure.

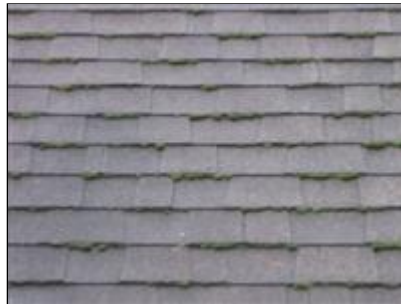
3.0 Picture 1

**3.0 MM** Moss has started to grow at the lower edges of the shingles on the north facing pitch of the garage nearest the driveway. I recommend removal of the moss to prevent excessive retention of moisture.

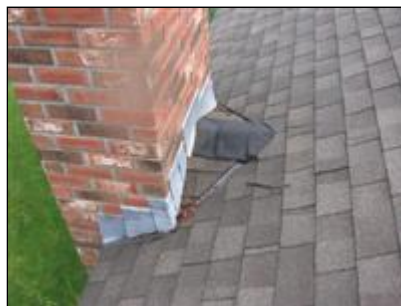
3.2 Picture 1

**3.2 FYI** The small pitched detail behind the chimney is a cricket. Spring and fall this should be cleared of debris to allow free drainage.

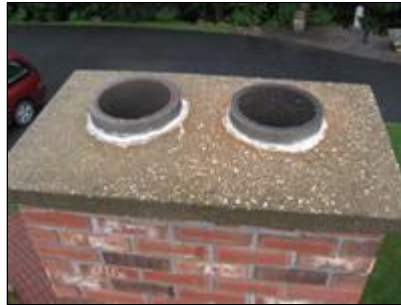
3.3 Picture 1

- MM The top surface of the concrete chimney cap has begun to erode. (Picture 1) A surface coat to seal it from moisture is recommended.
- MM A rain cap is recommended to keep rain water out of the flues and off the chimney cap. This will extend the life of all masonry components.
- Also see Item 6.5

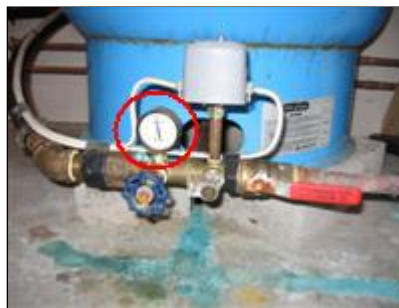
4.1 Picture 1

**4.1** MM The pressure gauge for the water supply system is not operating. Replacement is recommended.

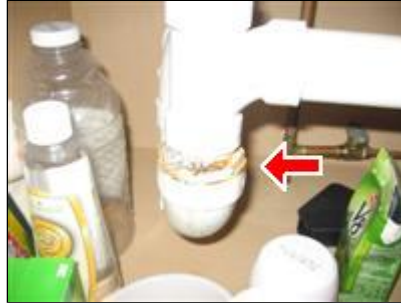
4.2 Picture 1

**4.2 MM** The kitchen drain trap has a very slow leak at one joint. I recommend further evaluation and repair as needed by a qualified contractor.

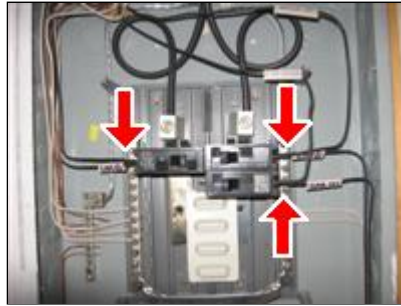
5.2 Picture 1

- RR, S All three circuit breakers in the garage are double tapped. (Picture 1) This can be easily corrected with the addition of three more breakers.
- One circuit breaker in the main panel is double tapped.
- I recommend further evaluation by a licensed electrician and correction as needed.

3.
  - RR, S All three circuit breakers in the garage are double tapped. (Picture 1) This can be easily corrected with the addition of three more breakers.

- One circuit breaker in the main panel is double tapped.
- I recommend further evaluation by a licensed electrician and correction as needed.

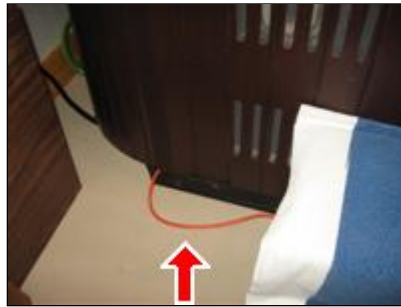
5.4 Picture 1

**5.4 (1)** MM, RR, S An orange cord somehow involved with the hot-tub is plugged into a wall socket near the tub. (Picture 1) Its purpose was not clear. It is plugged into a non-GFCI receptacle, and is therefore a safety hazard. I recommend it be discontinued until a safe connection is made, if desired..

4. (1) MM, RR, S An orange cord somehow involved with the hot-tub is plugged into a wall socket near the tub. (Picture 1) Its purpose was not clear. It is plugged into a non-GFCI receptacle, and is therefore a safety hazard. I recommend it be discontinued until a safe connection is made, if desired..
5. (3) RR, S Two receptacles in the basement hallway are hot-neutral reversed. I recommend further evaluation by a licensed electrician, and repair as necessary. Other receptacles in the general area should be double-checked.

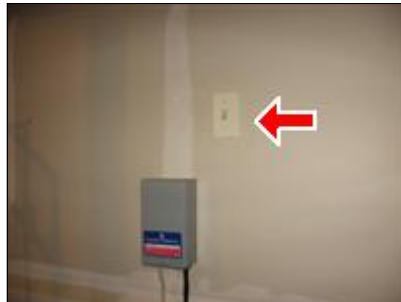
5.4 Picture 2

(2) MM The purpose of the switch near the pressure tank is not labeled and its function is unknown. It may be a shutoff for the pump circuit. I recommend you inquire with the seller.

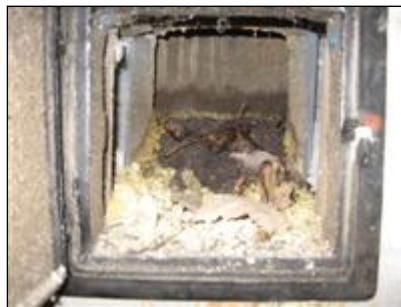
6.5 Picture 1

**6.5 (1) RR** A deposit of flue liner material at the chimney cleanout indicates deterioration of the flue liner. I recommend further evaluation by a chimney specialist to determine of the extent of the flue deterioration. If deterioration is advanced, the flue can be lined with a stainless steel flue.

7. (1) RR A deposit of flue liner material at the chimney cleanout indicates deterioration of the flue liner. I recommend further evaluation by a chimney specialist to determine of the extent of the flue deterioration. If deterioration is advanced, the flue can be lined with a stainless steel flue.
  8. (2) MM Water stains indicate the entry of rain water into the flue. This can accelerate deterioration. As noted in Item 3.3, a raincap is recommended.
-

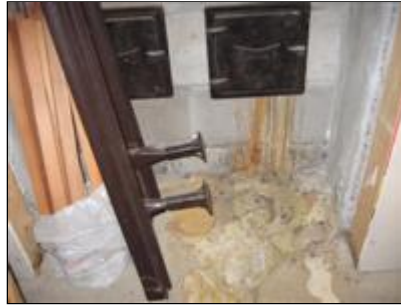
6.5 Picture 2

(2) MM Water stains indicate the entry of rain water into the flue. This can accelerate deterioration. As noted in Item 3.3, a raincap is recommended.
